BUILDING ANALYSIS REPORT

Perfect Choice Home Inspection Services Inc.

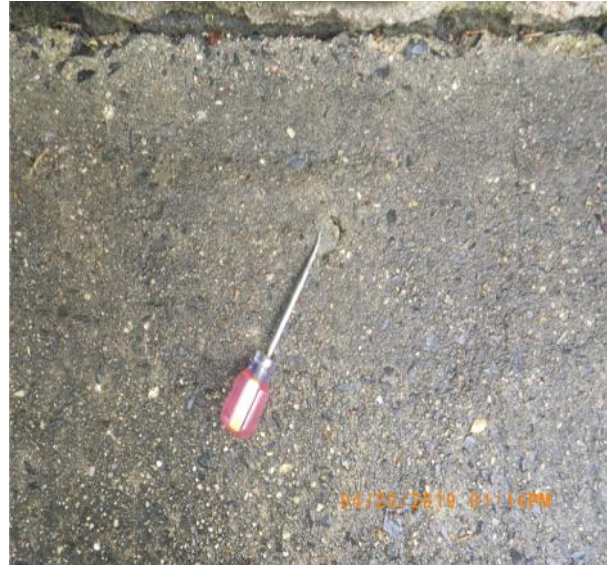
abc235 (44).JPG
Termite treatment-Drill marks from previous termite treatment by another company.

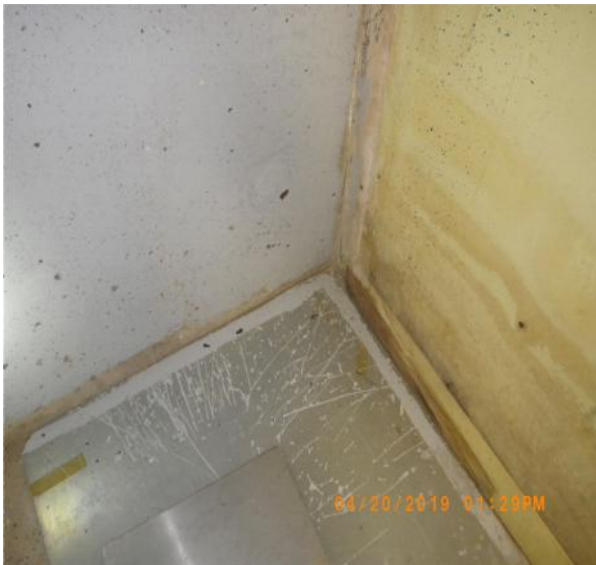
abc235 (53).JPG
Contractor specializing in basement waterproofing should examine signs of exterior water penetration into the basement noted on rear basement wall and repair as needed.

Contractor specializing in basement waterproofing should examine signs of past exterior water penetration into the basement noted on rear basement wall below basement window and repair as needed.

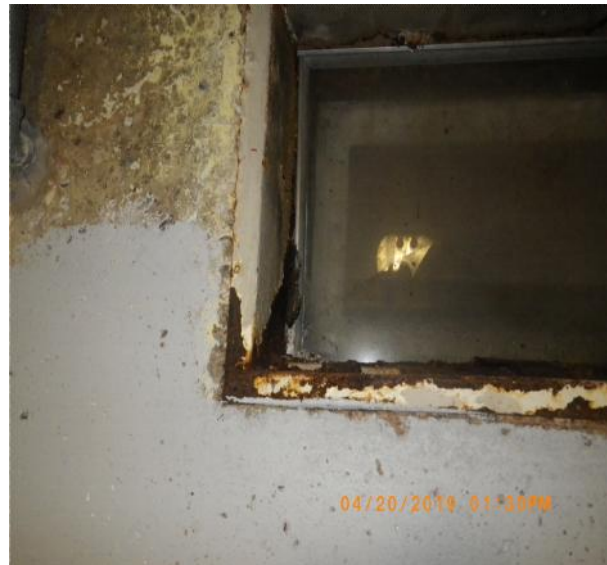
abc235 (54).JPG
Replace rear basement window (excessive damage to window frame and cracked window glass).

Replace rear basement window (excessive damage to window frame and cracked window glass).

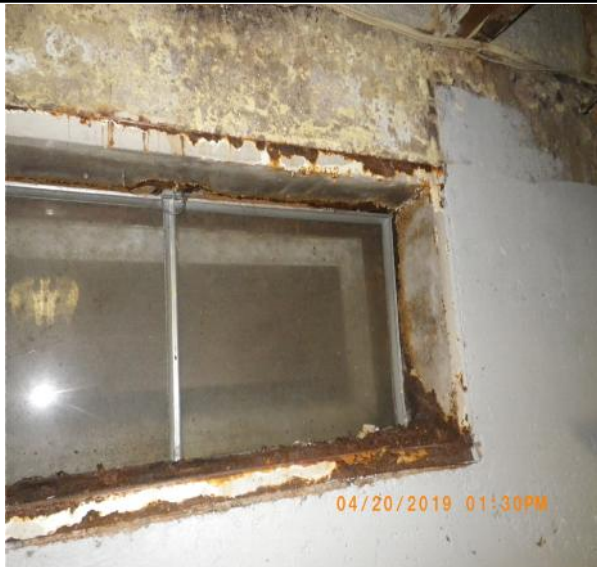
abc235 (55).JPG

Contractor specializing in basement waterproofing should examine signs of exterior water penetration into the basement noted on rear basement wall and repair as needed.

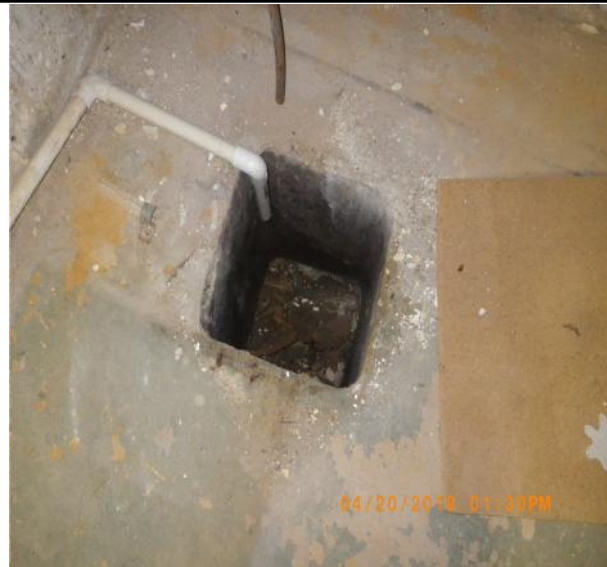
abc235 (56).JPG

Install sump pump in the basement (there is a pit, but no pump or drain pipe).

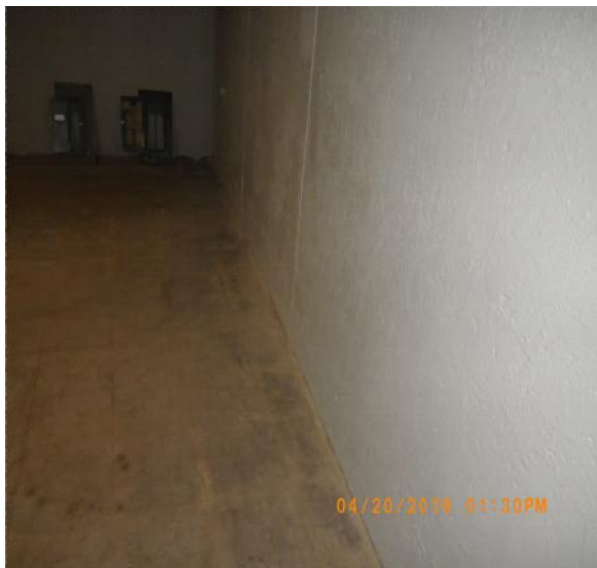
abc235 (57).JPG

Basement-Front and side basement wall have been recently painted, can't properly examine for signs of exterior water penetration on recently painted walls.

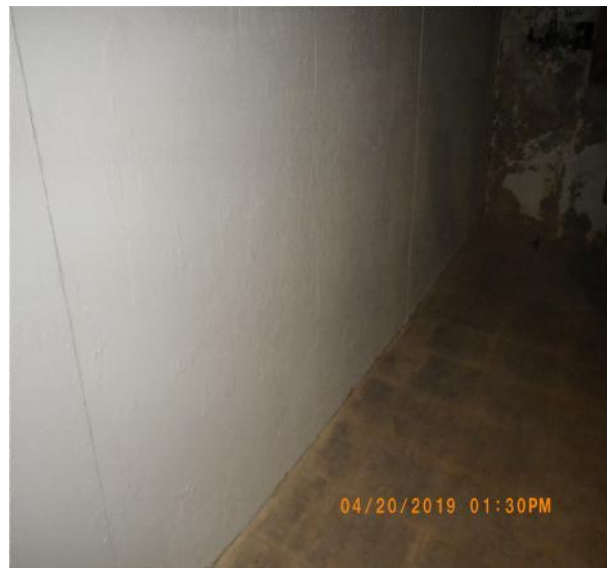
abc235 (58).JPG

Basement-Front and side basement wall have been recently painted, can't properly examine for signs of exterior water penetration on recently painted walls.

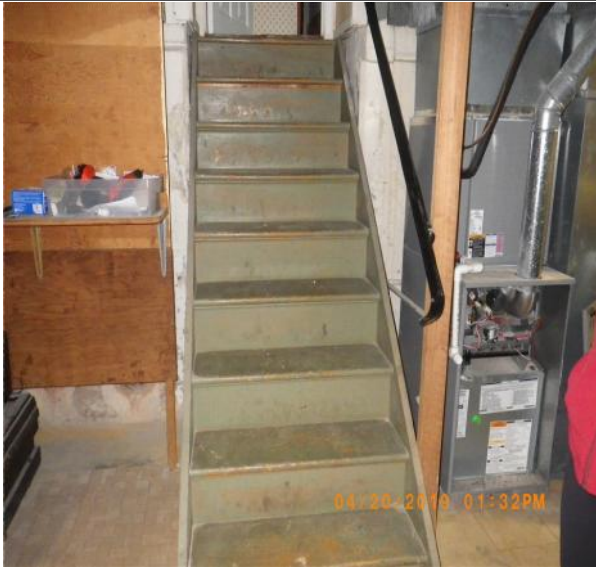
abc235 (61).JPG

Install railing on steps to the basement.

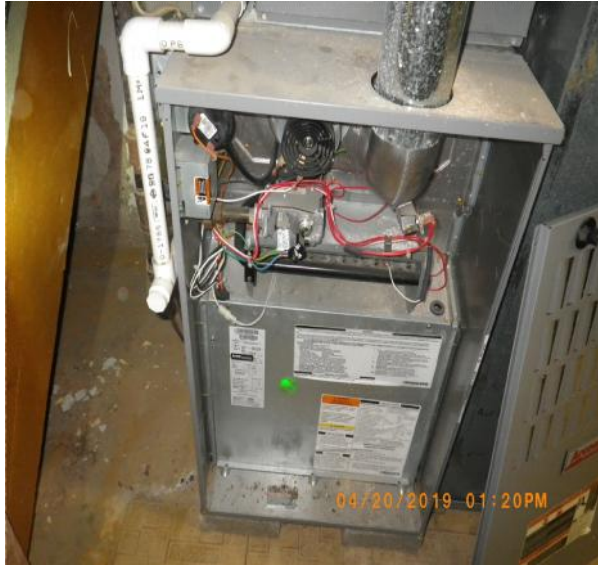
abc235 (47).JPG

Heating system past its estimated life expectancy. Anticipate replacement at any time.

Heating (main house)-Forced hot air furnace should be cleaned and serviced by HVAC mechanic a full examination performed on heat exchanger and certification issued.

Forced hot air furnace should be cleaned and serviced by HVAC mechanic a full examination performed on heat exchanger and certification issued (excessive rust noted in the lower portion of the heat exchanger).

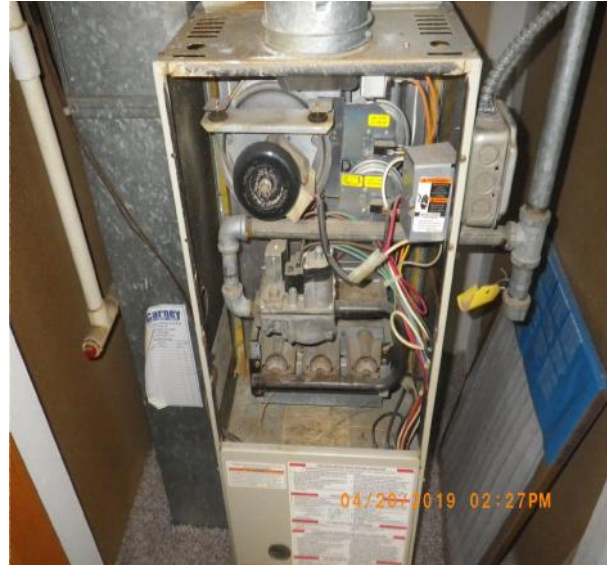
abc235 (69).JPG

Heating (in law suit)-Forced hot air furnace should be cleaned and serviced by HVAC mechanic a full examination performed on heat exchanger and certification issued

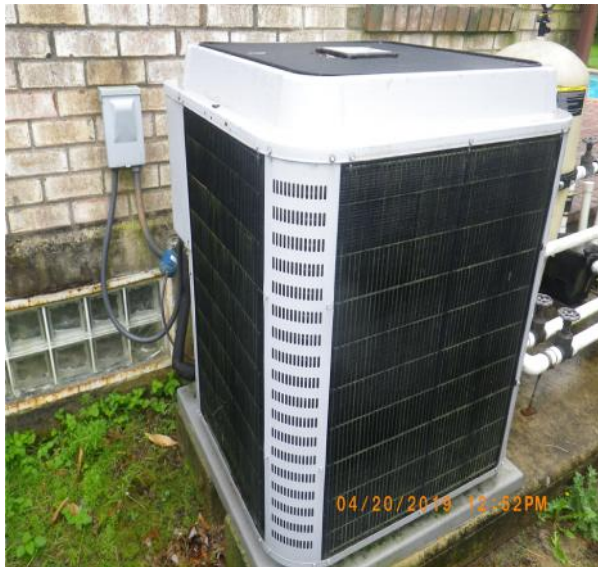
abc235 (29).JPG

Cooling (main house)-HVAC mechanic should examine not properly operating A/C system and repair as needed (difference between supply and return air temperature is 13 F.

HVAC mechanic should examine not properly operating A/C system and repair as needed (difference between supply and return air temperature is 13 F. During normal A/C system operation difference between supply and return air temperature should be 18F-20F)

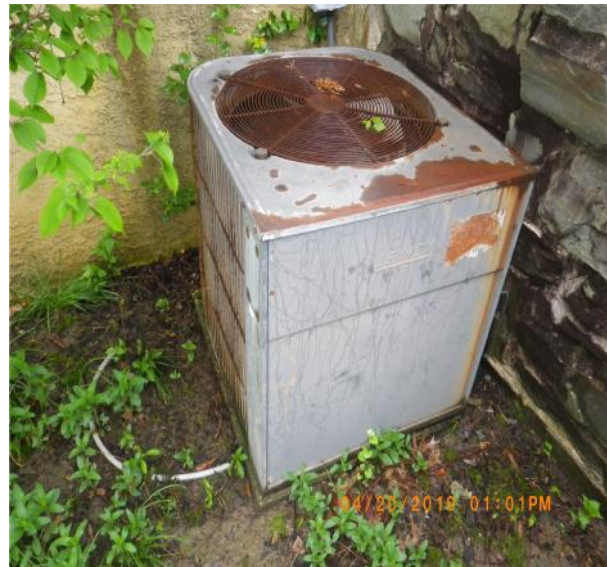
abc235 (42).JPG

Cooling (in law suit)-A/C system past its estimated life expectancy. Anticipate replacement at any time. HVAC mechanic should examine not properly operating A/C system

A/C system past its estimated life expectancy. Anticipate replacement at any time. HVAC mechanic should examine not properly operating A/C system and repair as needed (difference between supply and return air temperature is 10 F. During normal A/C system operation difference between supply and return air temperature should be 18F-20F)

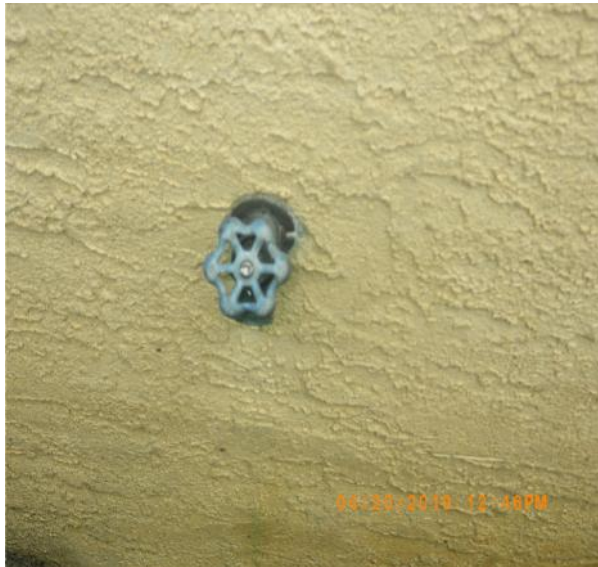
abc235 (22).JPG

Hose bib-Restore water supply to hose bibs and check operation before settlement, repair if needed.

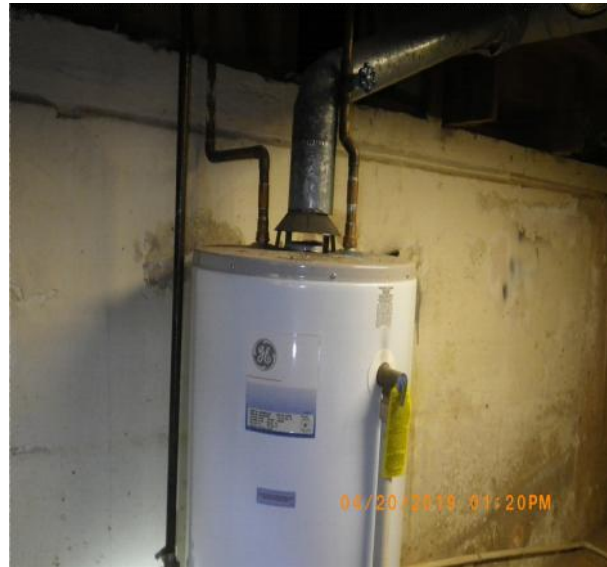
abc235 (48).JPG

Water heater-Water heater past its estimated life expectancy, anticipate replacement at any time.

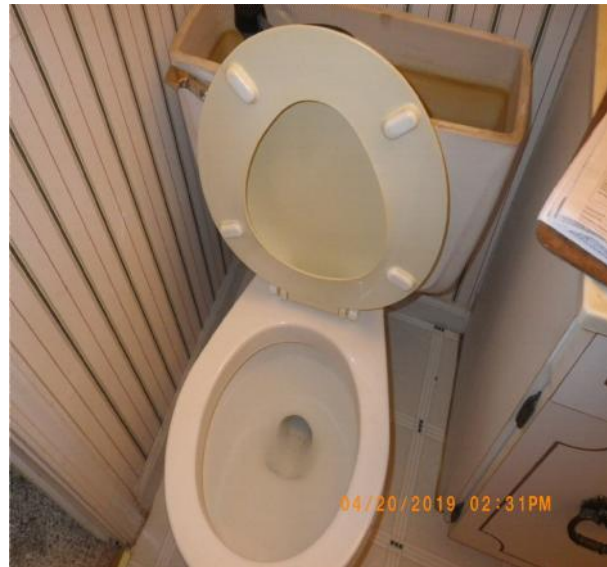
abc235 (70).JPG

Lower level bathroom-Restore water supply to the toilet and check toilet operation, repair if needed.

Restore water supply to the toilet and check toilet operation, repair if needed.

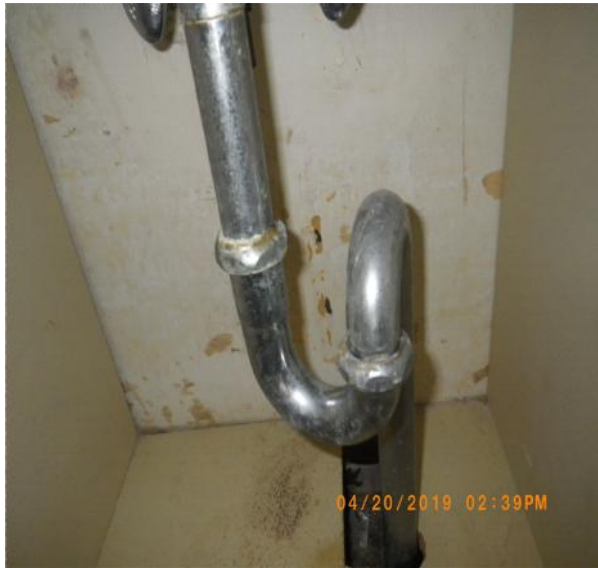
abc235 (71).JPG

1st floor bathroom-Replace deteriorated drain trap under bathroom sink.

Replace deteriorated drain trap under bathroom sink.

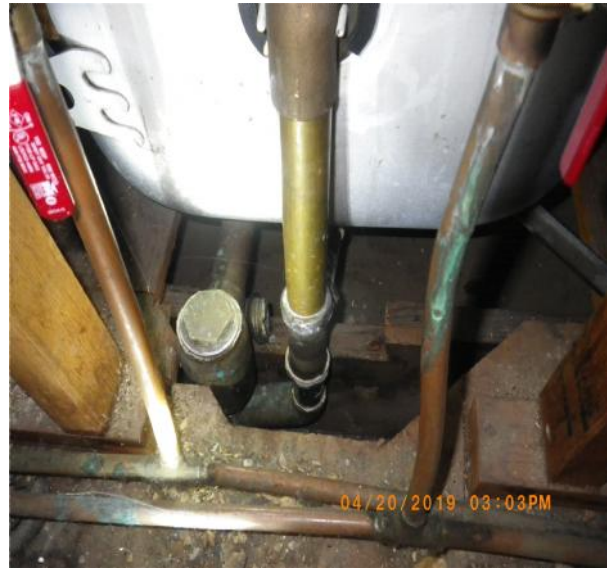
abc235 (74).JPG

2nd floor hall bathroom-No active leaks under bathtub at the time of inspection.

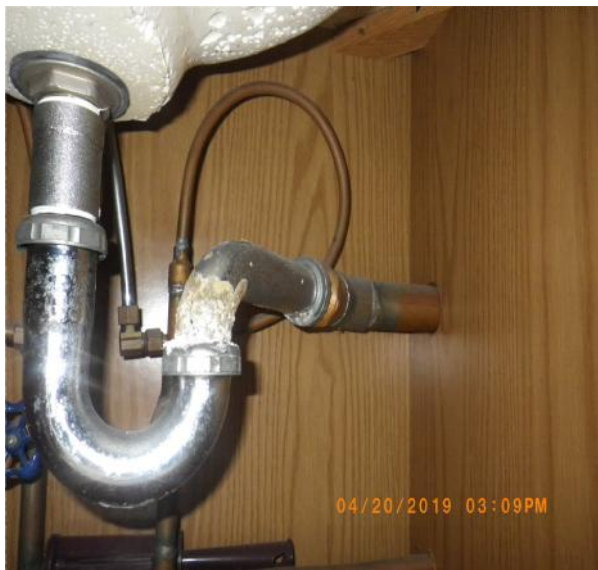
abc235 (76).JPG

Replace deteriorated drain trap under bathroom sink.

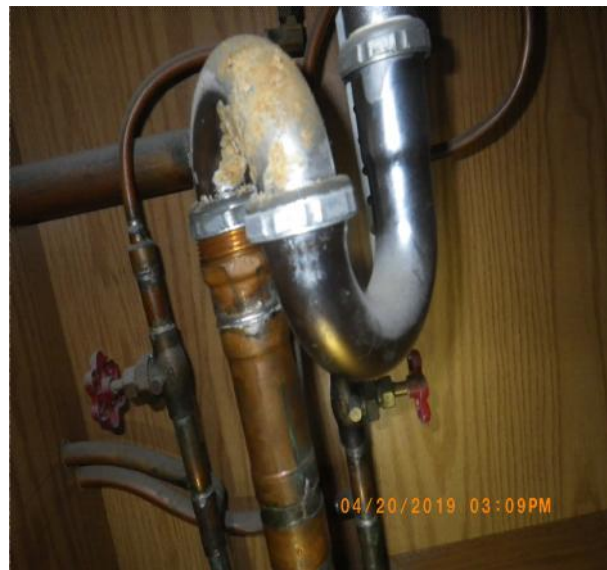
abc235 (77).JPG

Master bathroom- Replace deteriorated drain trap under bathroom sink.

Replace deteriorated drain trap under bathroom sink.

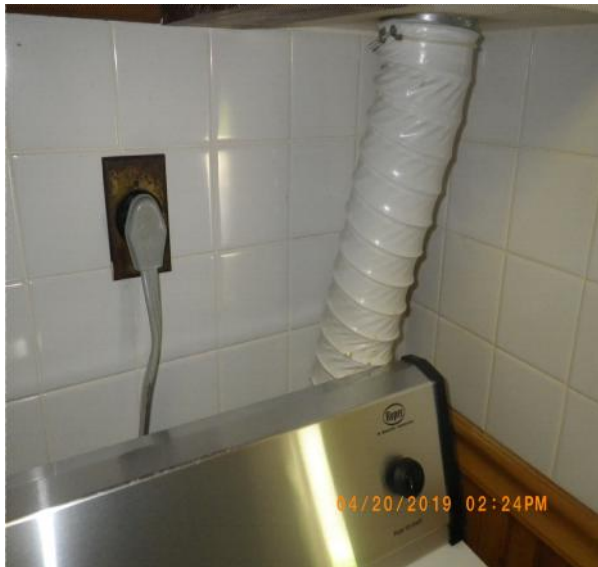
abc235 (67).JPG
Replace gas dryer vinyl vent hose with metal vent pipe (fire hazard).

Replace gas dryer vinyl vent hose with metal vent pipe (fire hazard).

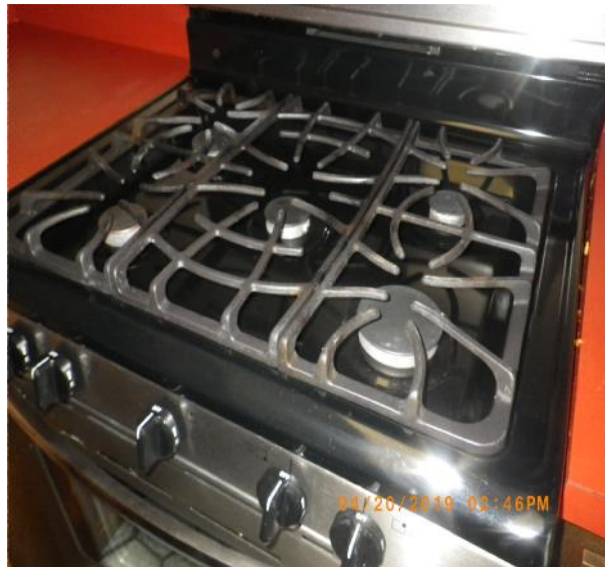
abc235 (73).JPG
Range-Repair non-operating gas range burners (burner would not ignite, safety hazard).

Repair non-operating gas range burners (burner would not ignite, safety hazard).

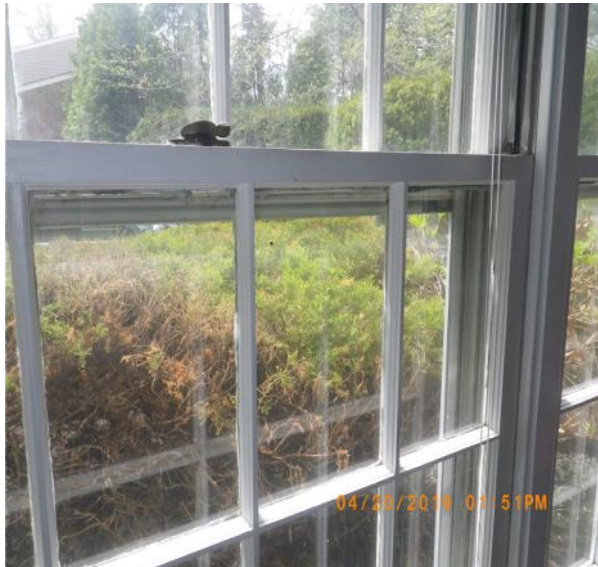
abc235 (64).JPG

Windows-All wood frame exterior windows past their estimated life expectancy. Anticipate replacement at any time.

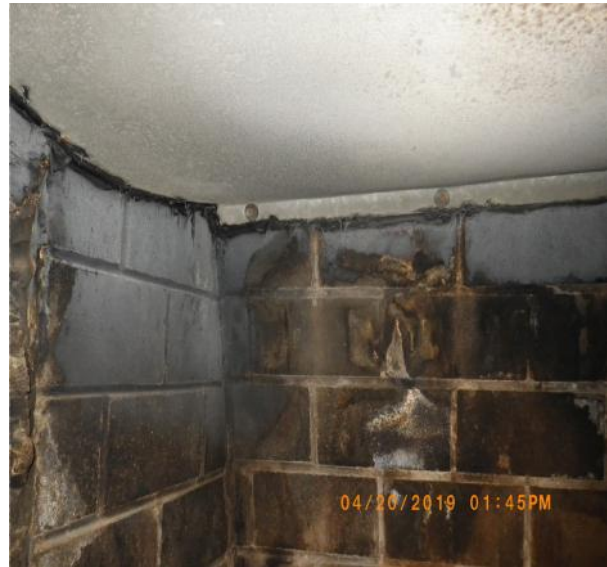
abc235 (62).JPG

Fireplace-Fireplace/chimney should be cleaned, repaired as needed and certified by licensed chimney sweep (chimney was sealed at the time of inspection, safety hazard).

Fireplace/chimney should be cleaned, repaired as needed and certified by licensed chimney sweep (chimney was sealed at the time of inspection, safety hazard).

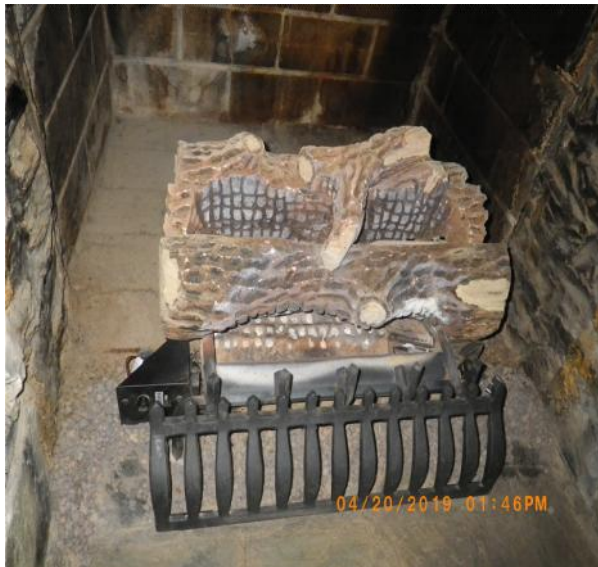
abc235 (63).JPG

Contractor specializing in gas inserts installation and repairs should examine gas insert in fire place, repair or replace if needed and issue certification.

Contractor specializing in gas inserts installation and repairs should examine gas insert in fire place, repair or replace if needed and issue certification.

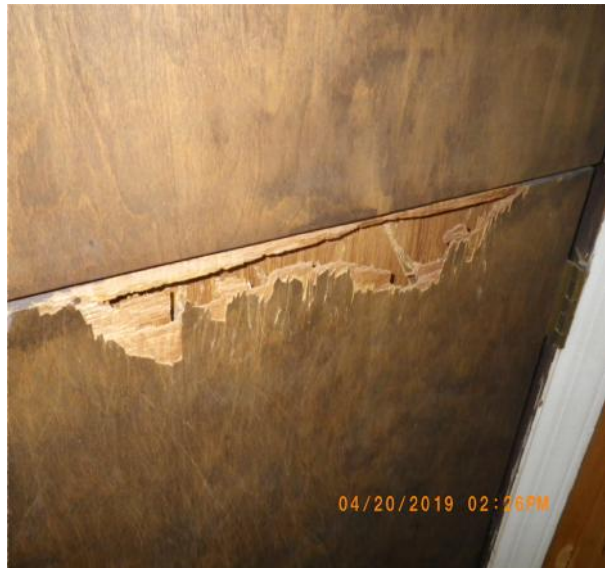
abc235 (68).JPG
Replace damaged door in the laundry room.

Replace damaged door in the laundry room.

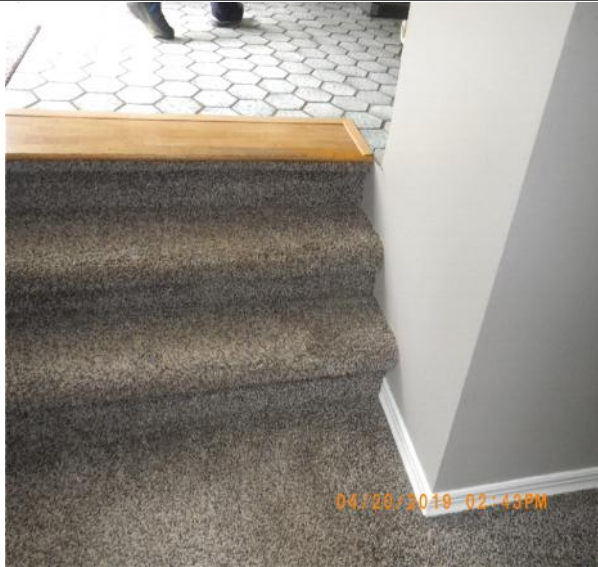
abc235 (72).JPG

Sttaps to the kitchen-Install handrail on stairs to the kitchen.

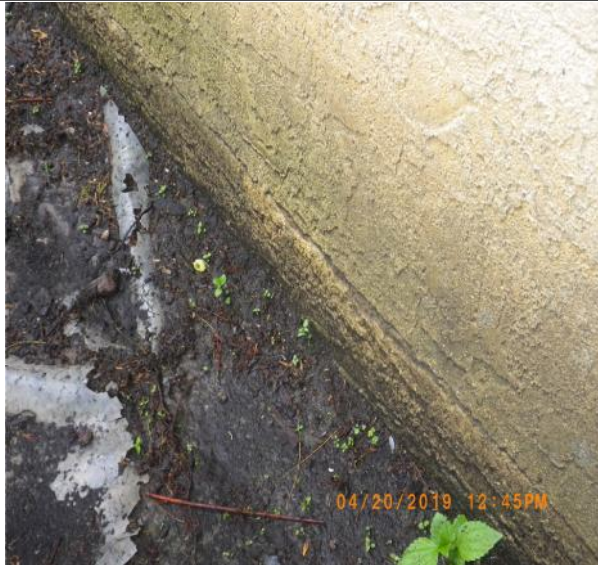
abc235 (19).JPG

Contractor specializing in stucco repairs should examine excessive cracks in stucco on left side exterior wall and repair or replace as needed (possible exterior water

Contractor specializing in stucco repairs should examine excessive cracks in stucco on left side exterior wall and repair or replace as needed (possible exterior water penetration under stucco).

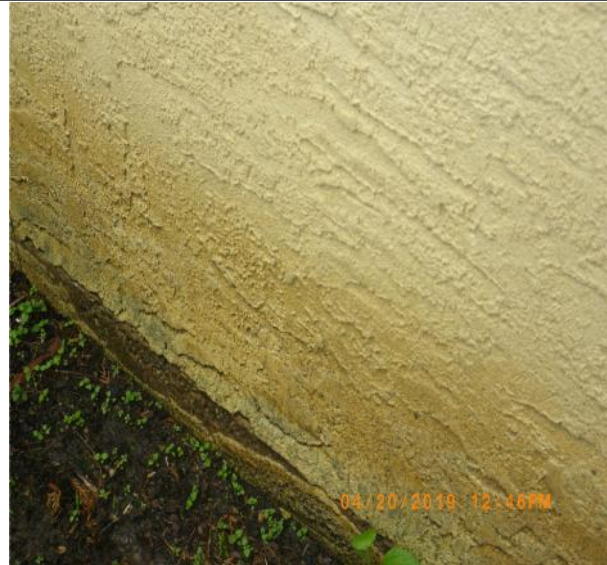
abc235 (20).JPG

Contractor specializing in stucco repairs should examine excessive cracks in stucco on left side exterior wall and repair or replace as needed (possible exterior water penetration

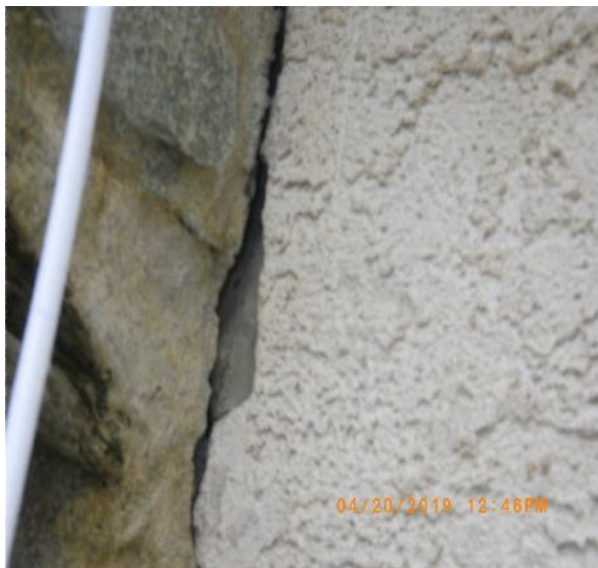
abc235 (21).JPG

Contractor specializing in stucco repairs should examine excessive cracks in stucco on left side exterior wall and repair or replace as needed (possible exterior water penetration

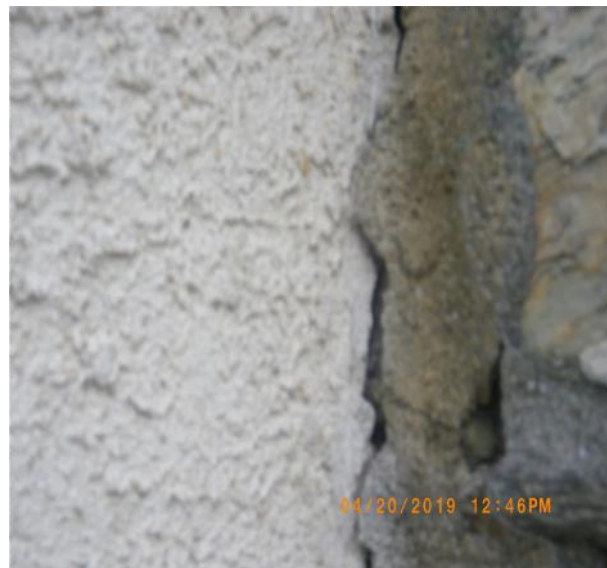
abc235 (24).JPG

Contractor specializing in stucco repairs should examine excessive cracks in stucco on left side exterior wall and repair or replace as needed (possible exterior water penetration

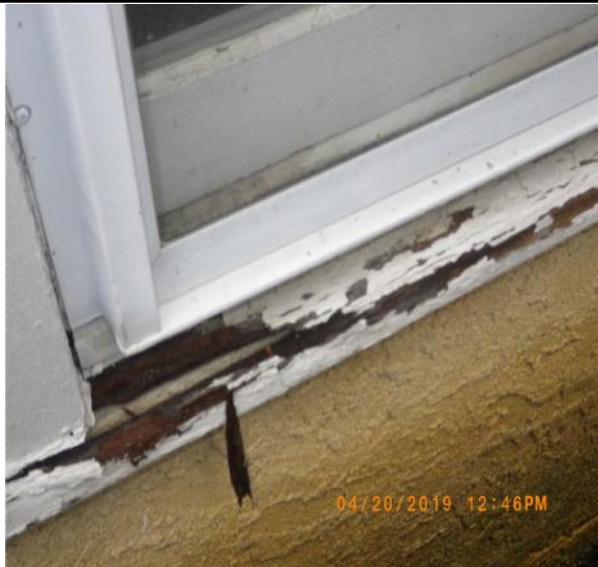
abc235 (23).JPG

Replace dry rot damaged window sill on left side wall.

Replace dry rot damaged window sill on left side wall below window.

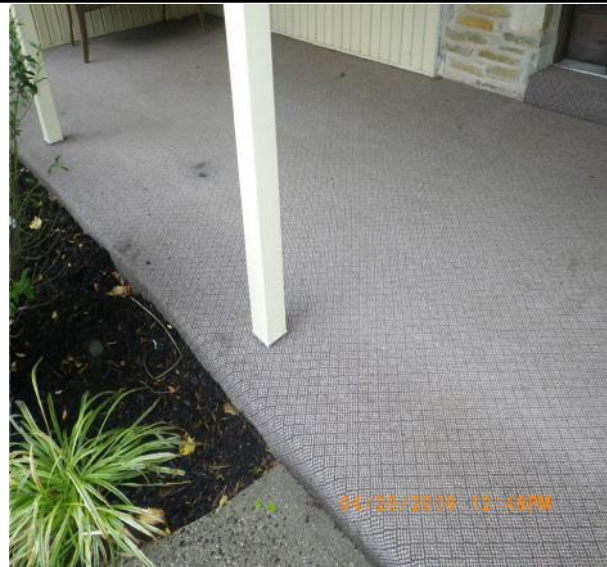
abc235 (26).JPG

Porch-Masonry contractor should remove carpet from concrete porch floor and repair or replace damaged concrete floor as needed (shifting concrete section noted in concrete

Masonry contractor should remove carpet from concrete porch floor and repair or replace damaged concrete floor as needed (shifting concrete section noted in concrete porch floor under the carpet).

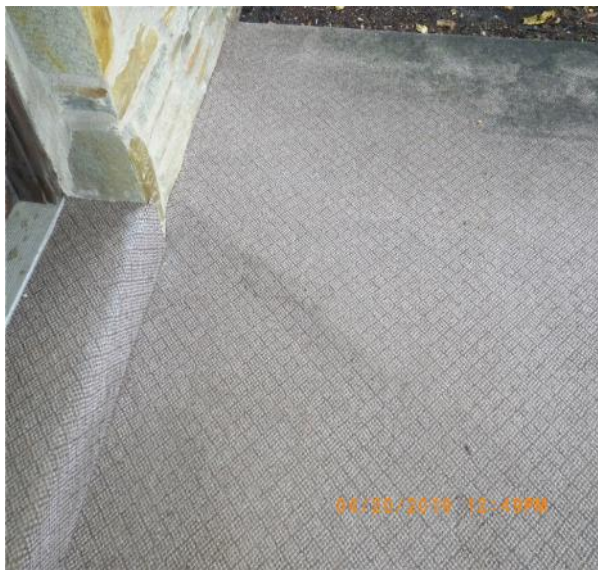
abc235 (27).JPG

Porch-Masonry contractor should remove carpet from concrete porch floor and repair or replace damaged concrete floor as needed (shifting concrete section noted in concrete

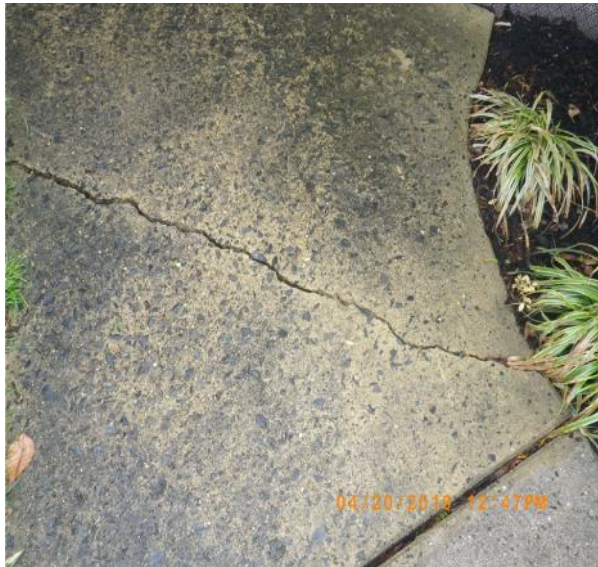
abc235 (25).JPG

Walkway-Replace damaged concrete section in front sidewalk (excessive settlement crack).

Replace damaged concrete section in front sidewalk (excessive settlement crack).

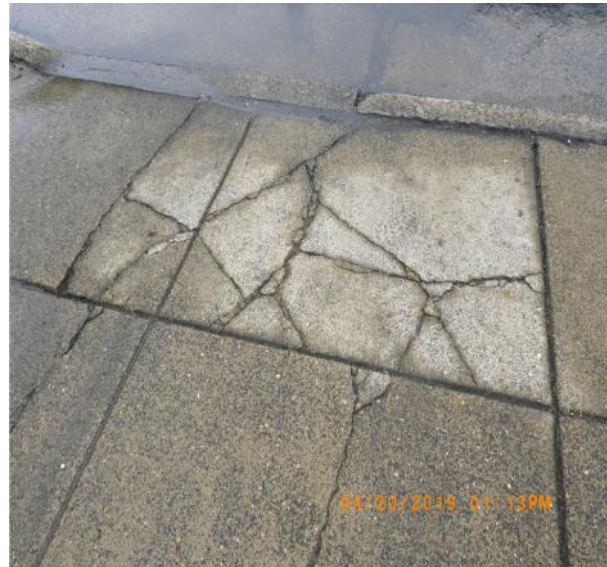
abc235 (43).JPG

Driveway-Replace damaged concrete section at beginning of driveway (excessive cracks).

Replace damaged concrete section at beginning of driveway (excessive cracks).

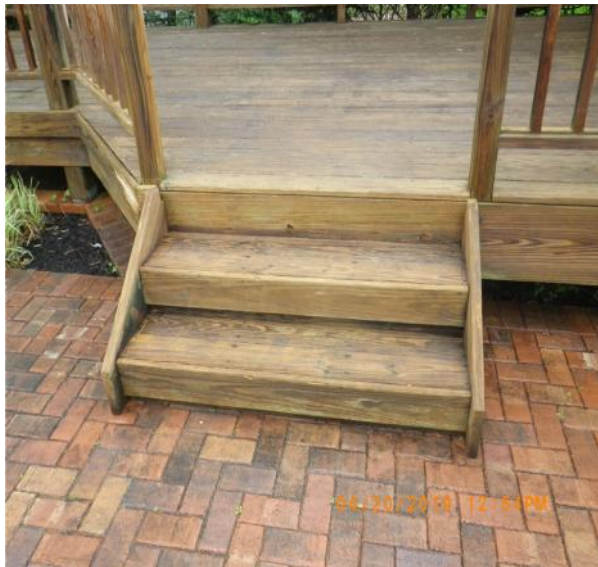
abc235 (30).JPG

Install railing on steps to the deck.

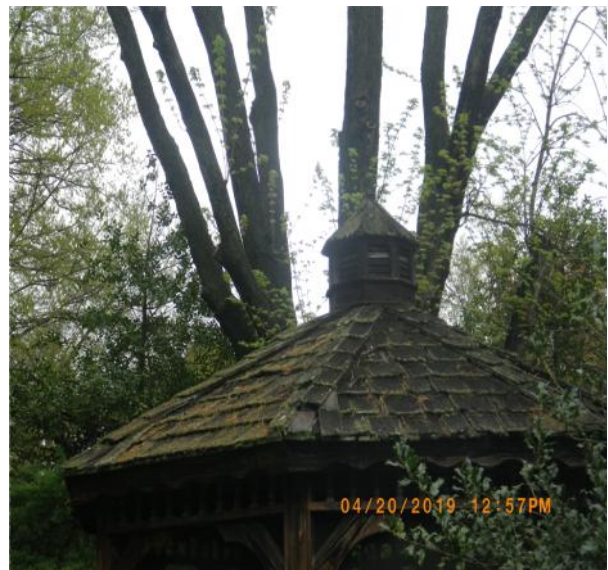
abc235 (36).JPG
Replace roof covering.

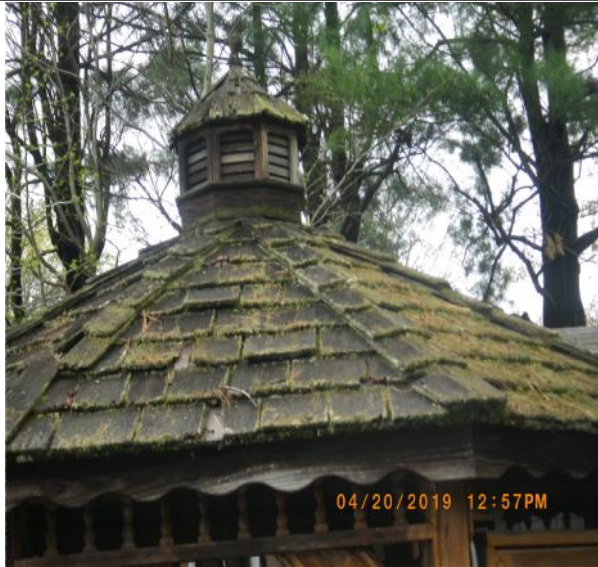
abc235 (37).JPG
Replace roof covering.

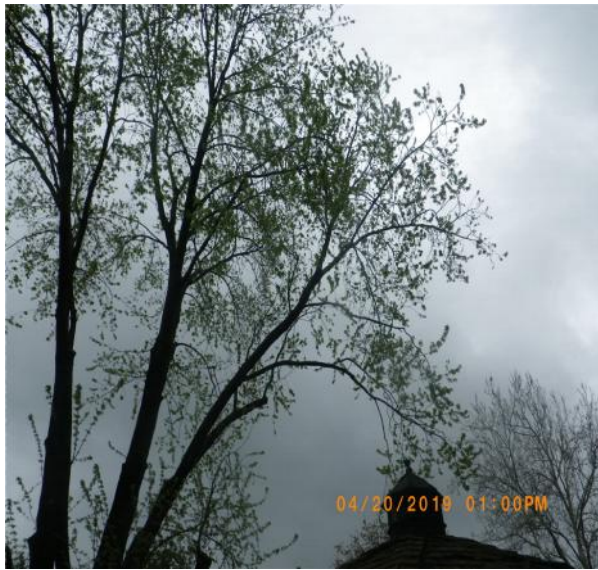
abc235 (41).JPG
Trees and shrubbery-Trees and shrubbery should be cut away from the house.
